What did I learn from thermal images of my home?

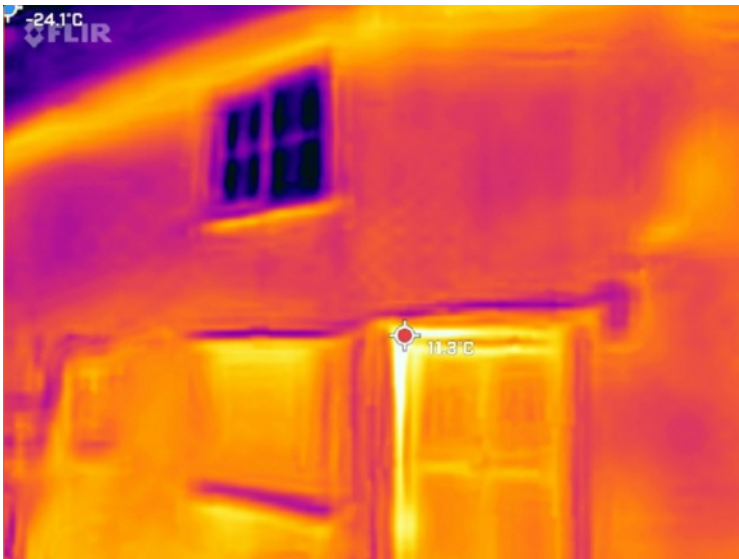
Blue window - we don't heat upstairs room - cool. Crittal single glazed windows.

Back door - look at the leakage of heat around the back door.

Warm soffits [below roof line]? Could be leaking heat from door collecting there, or even heat from under-insulated roof leaking out.

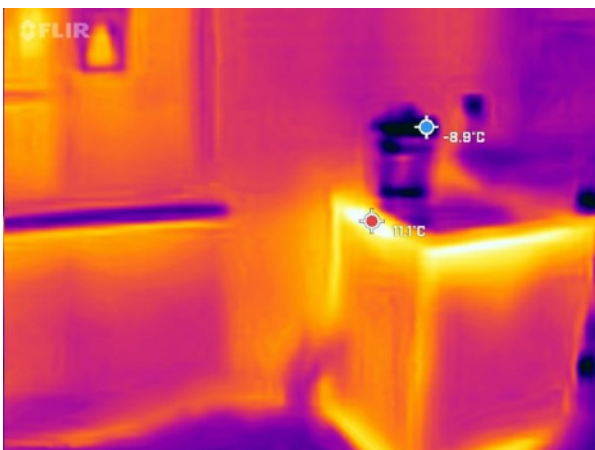
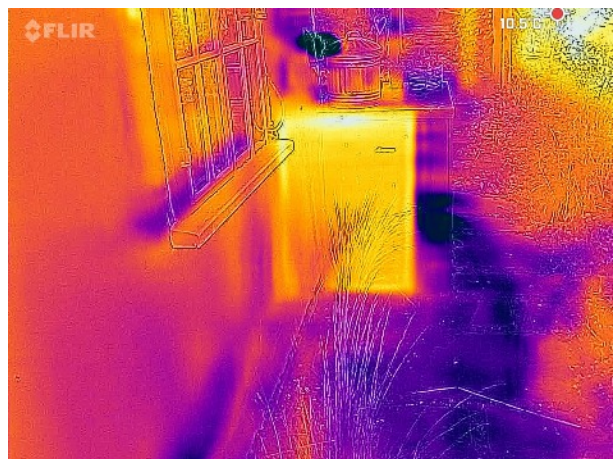
The oil CH.boiler outside - in a green box which is nominally insulated, but by the look of the bright light at the top / bottom, it could benefit from more. At the moment it's heating the garden.

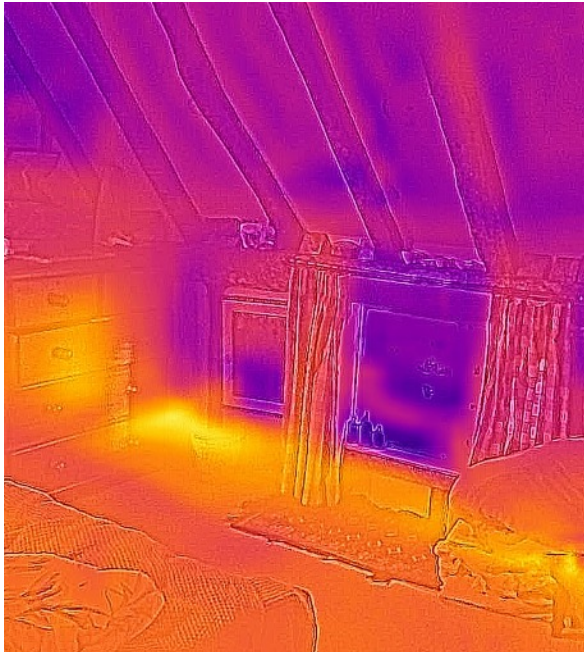
The roof is inadequately insulated, I know.

This bedroom is not really heated, but I now know where the CH pipes are under the floor!

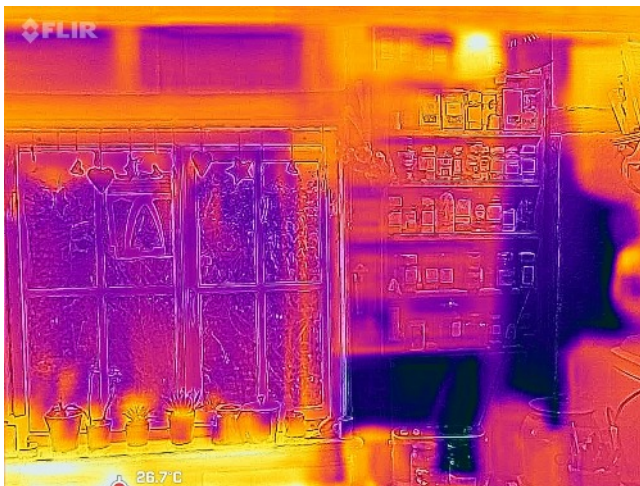
In kitchen - radiator under window with secondary glazing affixed.

Above the window, and to the right of the spice rack, it's just a one brick thick wall - far cooler than I expected!

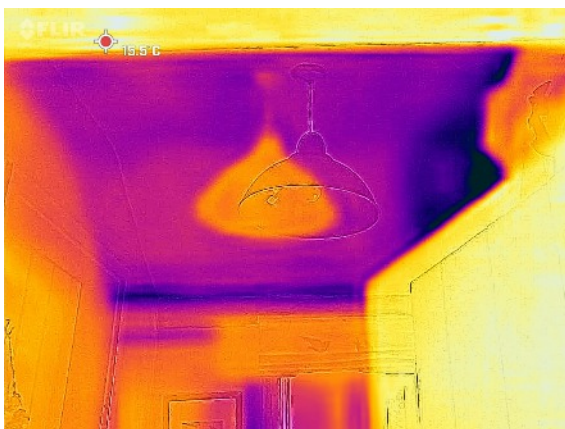
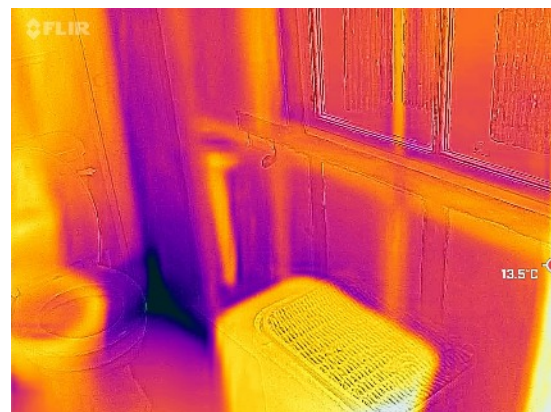
Bathroom - lean to construction. No access to ceiling so not insulated. Outside wall only 1 brick thick. Always cold, so this summer I insulated the wall with 25mm foam and wood T&G.

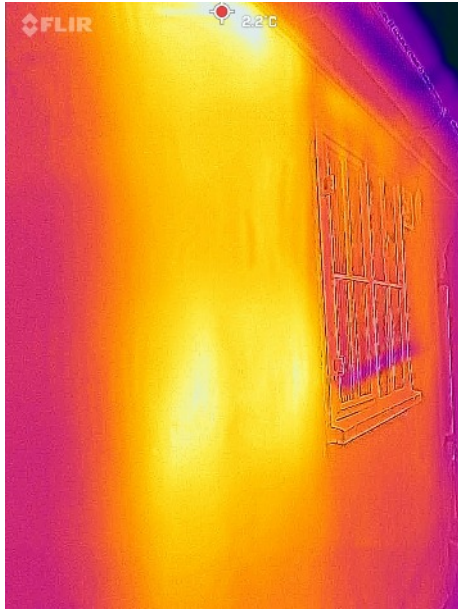
The bathroom wall from outside.

Looking at the radiator through the wall.

Hope previously described insulation on the wall, and foam/foil behind radiator will make a difference!

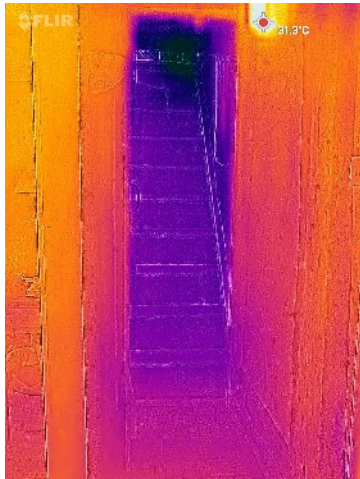
We normally keep the door closed to the stairs and upstairs - warm air goes up and cold air comes down.

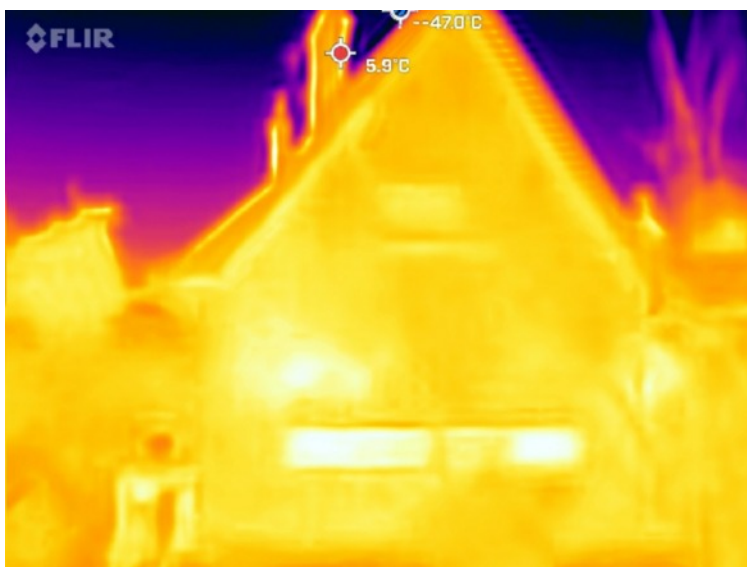
Old Suffolk cottages - wooden frame with 1 brick thick walls - variable plaster inside.

We light up the village on a cold night - in thermal imaging terms.

This costs us extra money in fuel, and requires excessive carbon output.
